**BIOLOGICAL RESOURCES SURVEY REPORT
FOR THE SAN DIEGO SECTOR BORDER WALL PROTOTYPE
U.S. CUSTOMS AND BORDER PROTECTION
SAN DIEGO COUNTY, CALIFORNIA**

October 2017

**U.S. Customs and Border Protection
Facilities Management and Engineering
Border Patrol and Air and Marine
Program Management Office
Contract No.: GS10F0058K
Task Order: HSBP1017F00134
Work Order: 01**

**Gulf South Research Corporation
8081 Innovation Park Drive
Baton Rouge, Louisiana 70820**

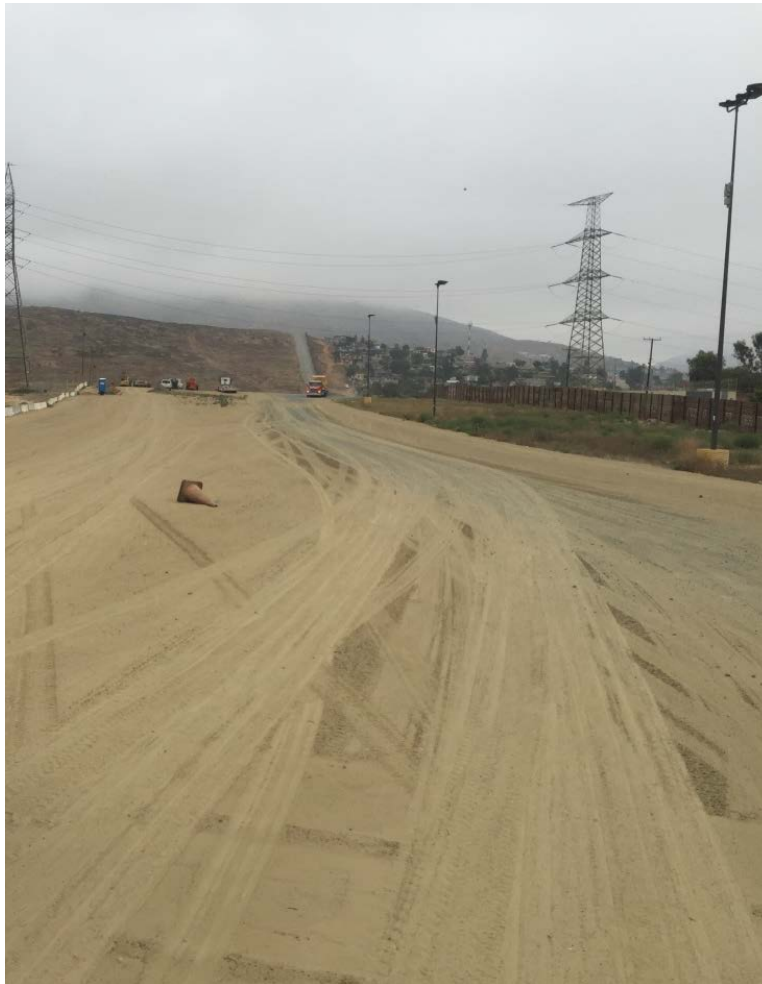
Photograph 1. SDC Border Wall Prototype Project construction area.

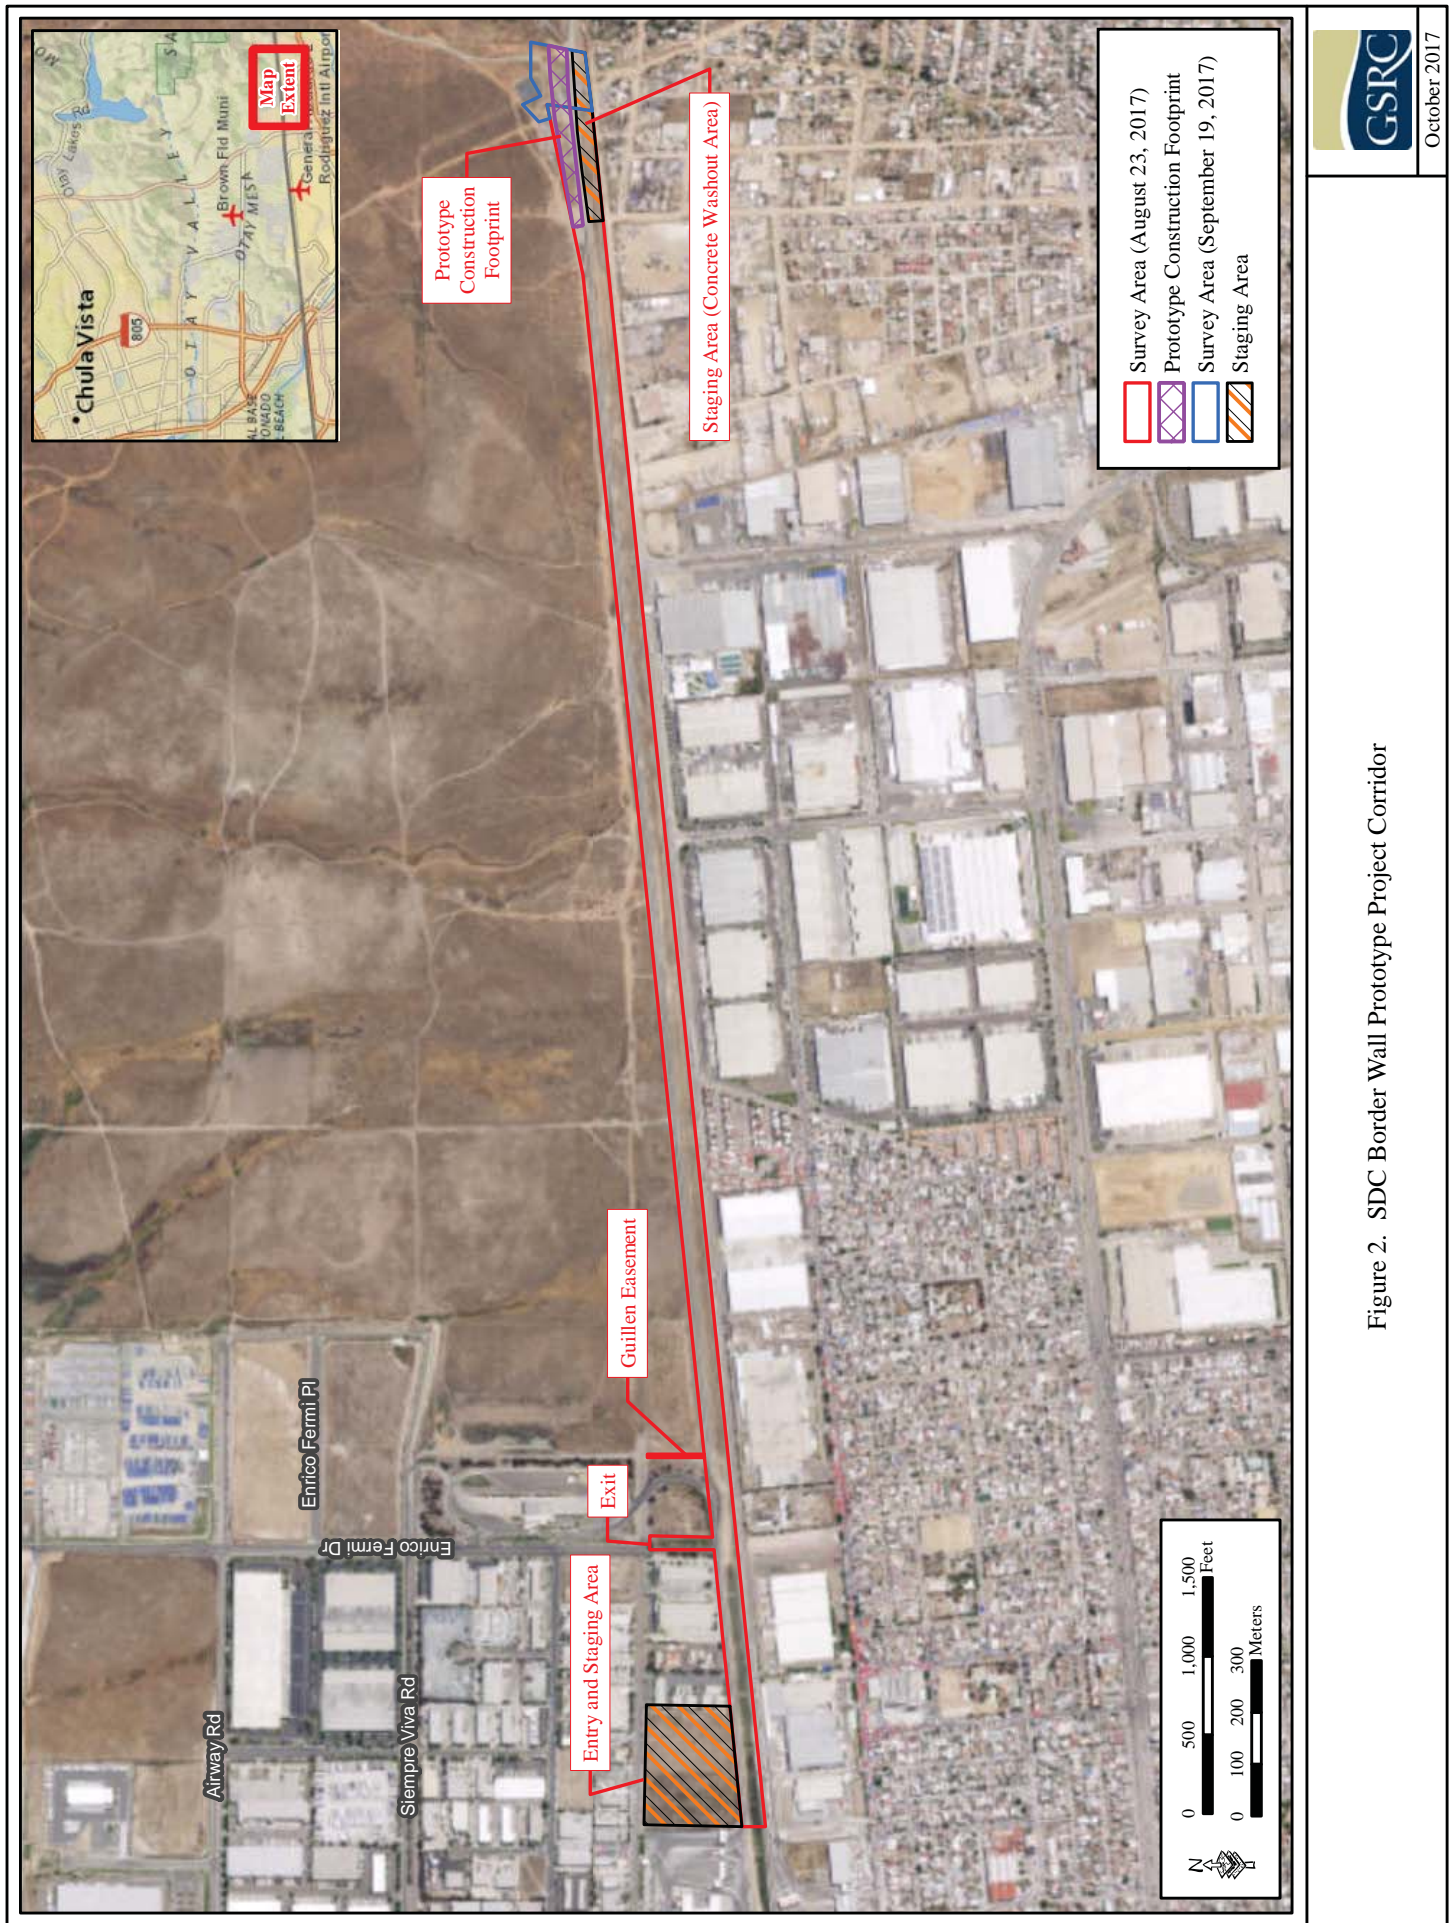
Figure 2. SDC Border Wall Prototype Project Corridor

The Project Corridor consists of a 10-acre staging area (General Service Administration [GSA] Lot), three access roads, the border wall prototype construction footprint (Construction Footprint), an all-weather road, and a staging area (concrete washout area) within the border enforcement zone (Figure 2). The Construction Footprint is an approximately 120-foot by 1,000-foot area located in the extreme eastern portion of the Project Corridor. Access to the Construction Footprint is along the border road from the west and via two north-south roads near the Otay Mesa LPOE. These access roads may need to be repaired or improved to support the transport of heavy trucks and equipment to the Construction Footprint.

Biological resource surveys were performed across the entire Project Area (Figure 2). The Project Area is situated on a mesa and has very little relief. The landscape slopes down gradually from northeast to southwest. Elevations in the Project Area range from 520 feet to 570 feet above mean sea level.

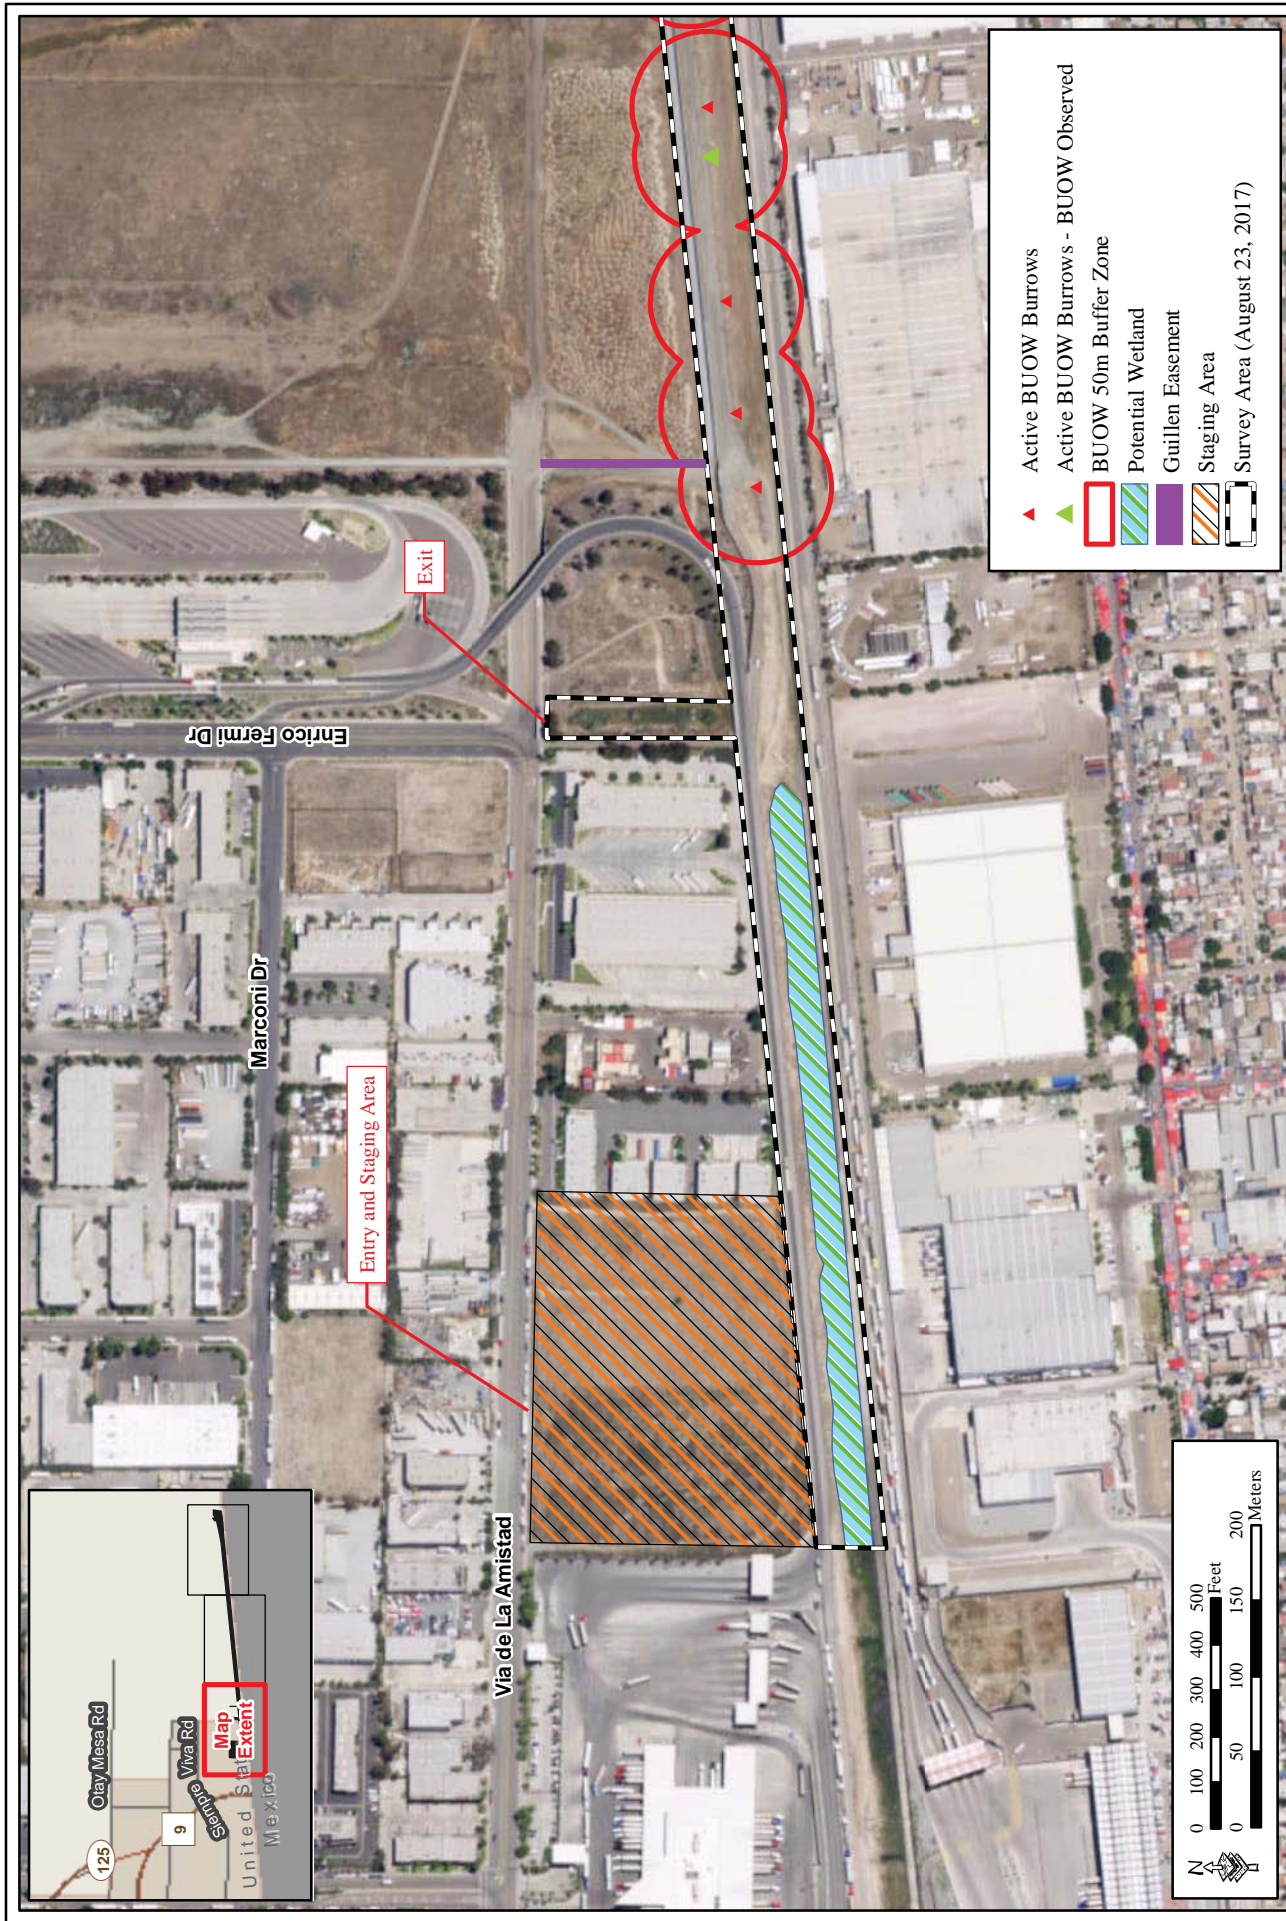
Figure 4. Biological Survey Findings Map 1

The 10-acre staging area in the GSA Lot is heavily disturbed (Figures 3 and 4). Vegetation in the area is dominated by non-native species and includes Russian thistle (*Salsola tragus*), crown daisy (*Glebionis coronaria*), prickly lettuce (*Lactuca serriola*), soft brome (*Bromus hordeaceus*), compact brome (*B. madritensis*), and Italian rye grass (*Festuca perennis*) (Photograph 2). This area appears to have been graded, leveled, and mowed frequently. Immediately south of the GSA Lot, within the enforcement zone, is a low area that conveys some stormwater runoff. This area has hydrology and vegetation that is consistent with wetland habitat (Figure 4). This area too shows evidence of frequent mowing and other disturbances. Dominant plant species included Bermuda grass (*Cynodon dactylon*), cattails (*Typha* sp.), willow (*Salix* sp.), crimson fountaingrass (*Pennisetum setaceum*), tall flatsedge (*Cyperus eragrostis*), knotgrass (*Paspalum distichum*), and barnyard grass (*Echinochloa crus-galli*) (Photograph 3).

The Exit Area is an improved road extending from Enrico Fermi Road to the secondary border enforcement fence (Figures 3 and 4). The road is bound by industrial buildings to the west and a stormwater collection basin to the east. The vegetation community in the immediate vicinity of the access road is described as non-native grassland with mixed forbs and shrubs dominated by brome grass, Russian thistle, prickly lettuce, tamarisk (*Tamarisk* sp.), and Australian saltbush (*Atriplex semibaccata*). There is a line of large non-native Eucalyptus trees (*Eucalyptus* sp.) along the western edge of the access road (Photograph 4).

The Guillen Easement Area is an unpaved heavily disturbed roadway area trending south of Via de La Amistad to the secondary border fence (see Figures 3 and 4). This area is bound by industrial buildings and border enforcement infrastructure to the west, disturbed non-native grassland to the east, and the border enforcement zone to the south. The vegetation community in the immediate vicinity is described as non-native grassland with mixed forbs and shrubs. The survey area is completely disturbed and is nearly devoid of vegetation (Photograph 5).

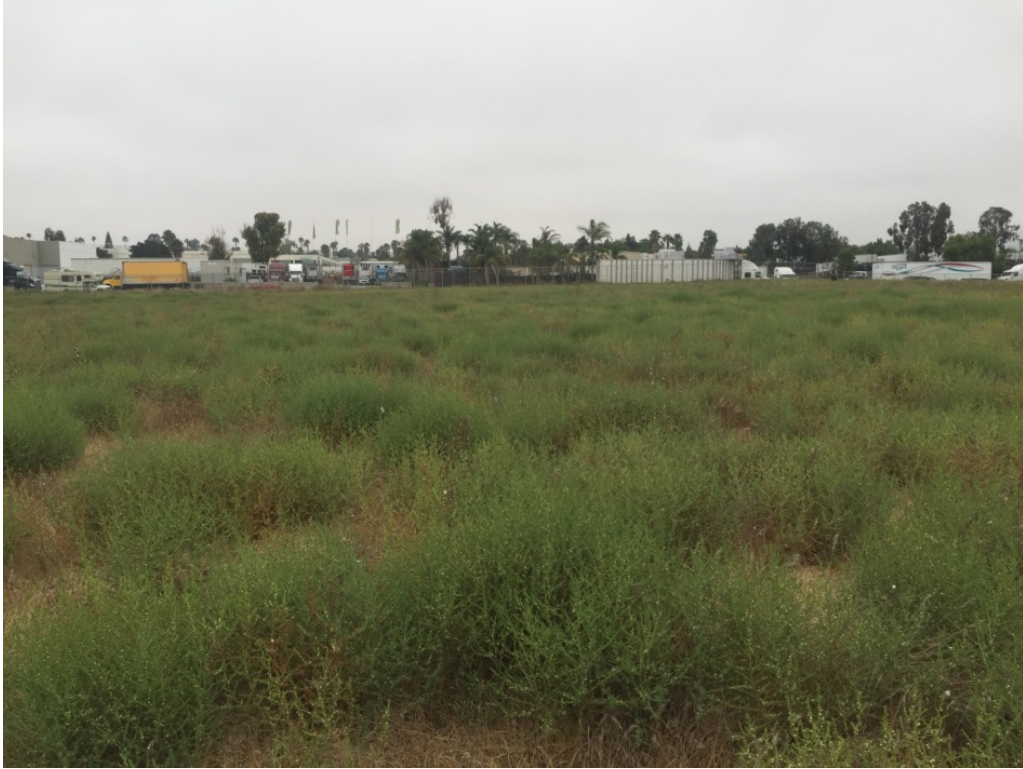
Photograph 2. The 10-acre staging area (GSA Lot) is heavily disturbed with non-native grassland and shrub mix.

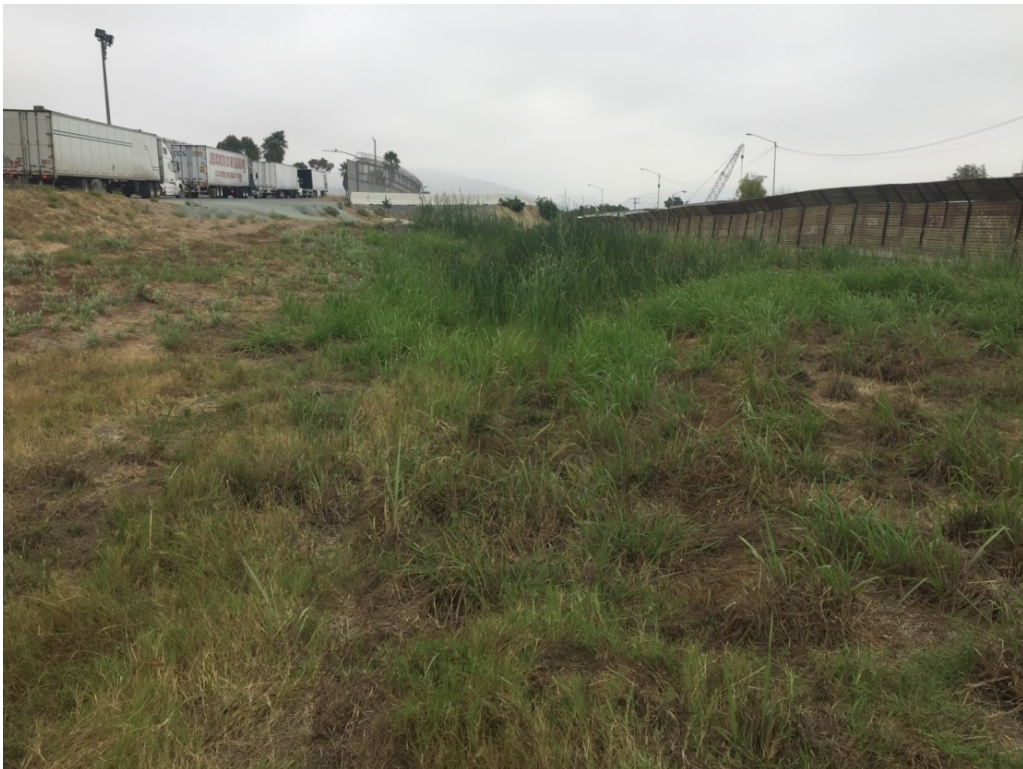
Photograph 3. A heavily disturbed non-native wetland habitat adjacent to the 10-acre staging area.

- GSRC biologists identified a potential jurisdictional wetland area south of the entry and GSA Lot within the border enforcement zone. This area should be avoided during construction activities; therefore, no impacts on wetlands would occur.

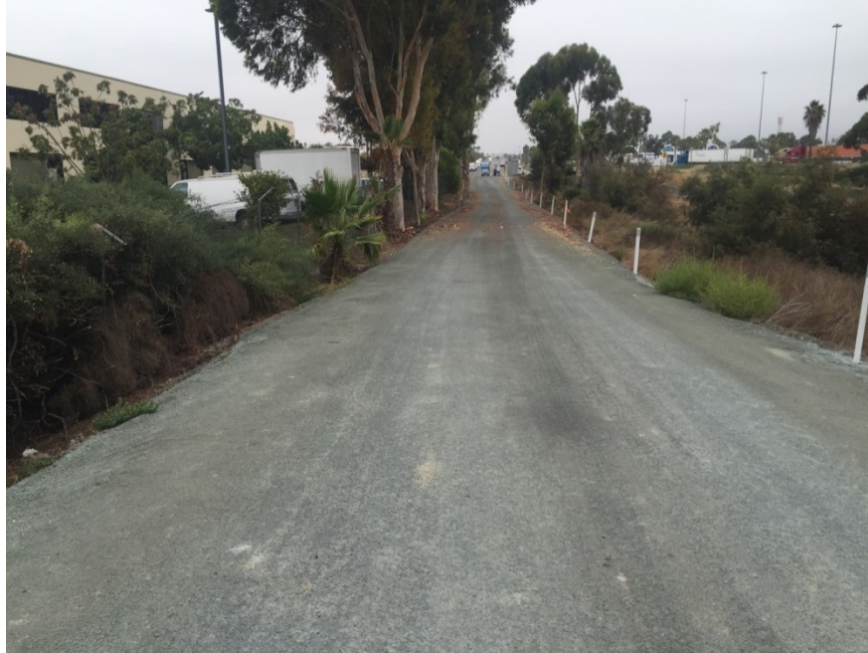
Photograph 4. The proposed exit survey area consists of a developed roadway lined with disturbed non-native shrub and grass habitat.

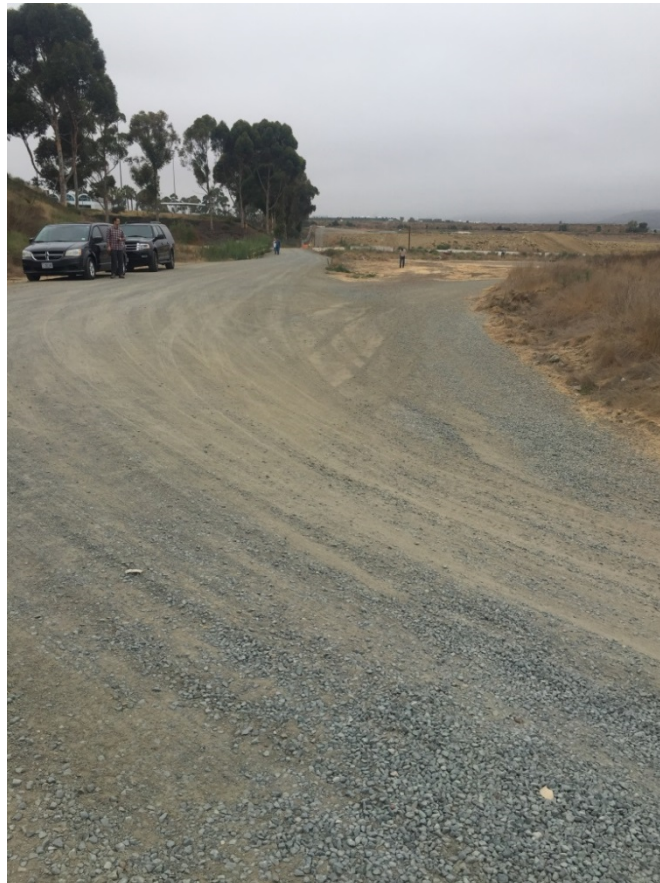
Photograph 5. The Guillen Easement is heavily disturbed and nearly devoid of vegetation. Disturbed non-native grassland habitat occurs to the east.

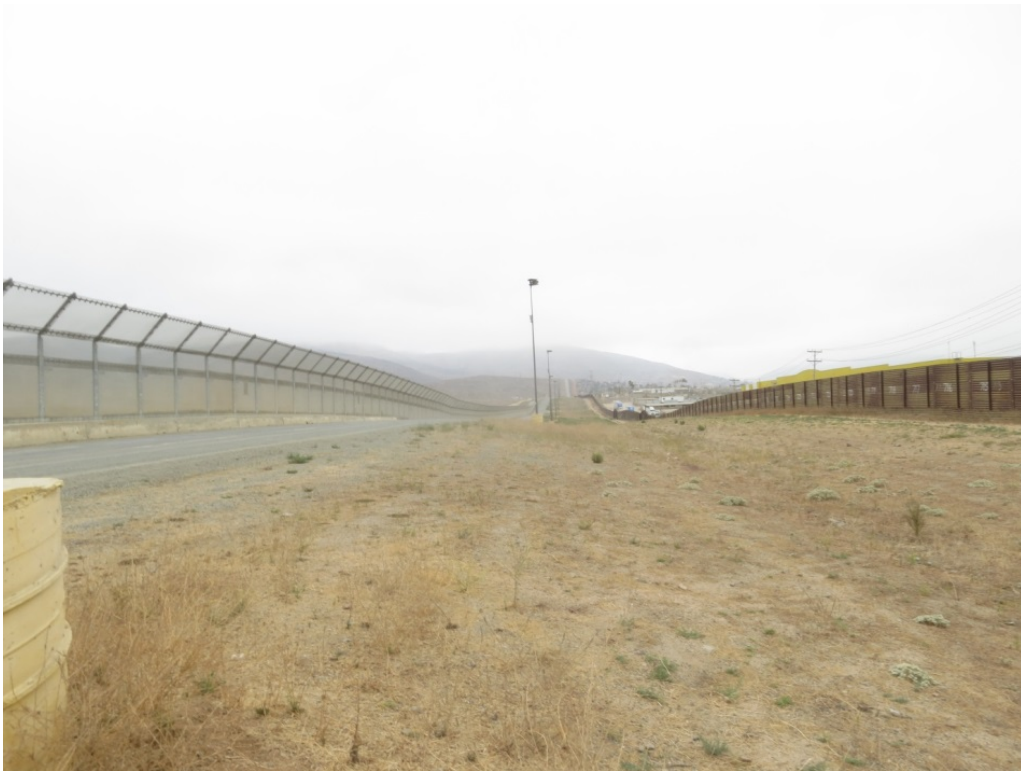
The enforcement corridor is heavily disturbed and currently serves as a border enforcement zone with primary and secondary border fences, all-weather road, and border lighting and surveillance technology (see Figure 3 and Figure 5). Disturbances include frequent mowing of vegetation and vehicular traffic (Photograph 6). The vegetation community in the immediate vicinity is described as non-native grassland with mixed non-native forbs dominated by brome grass, Russian thistle, prickly lettuce, and Australian saltbush.

Photograph 6. The enforcement zone survey area connecting the construction footprint and access points is heavily disturbed and consists of non-native grassland habitat with mixed non-native forbs.

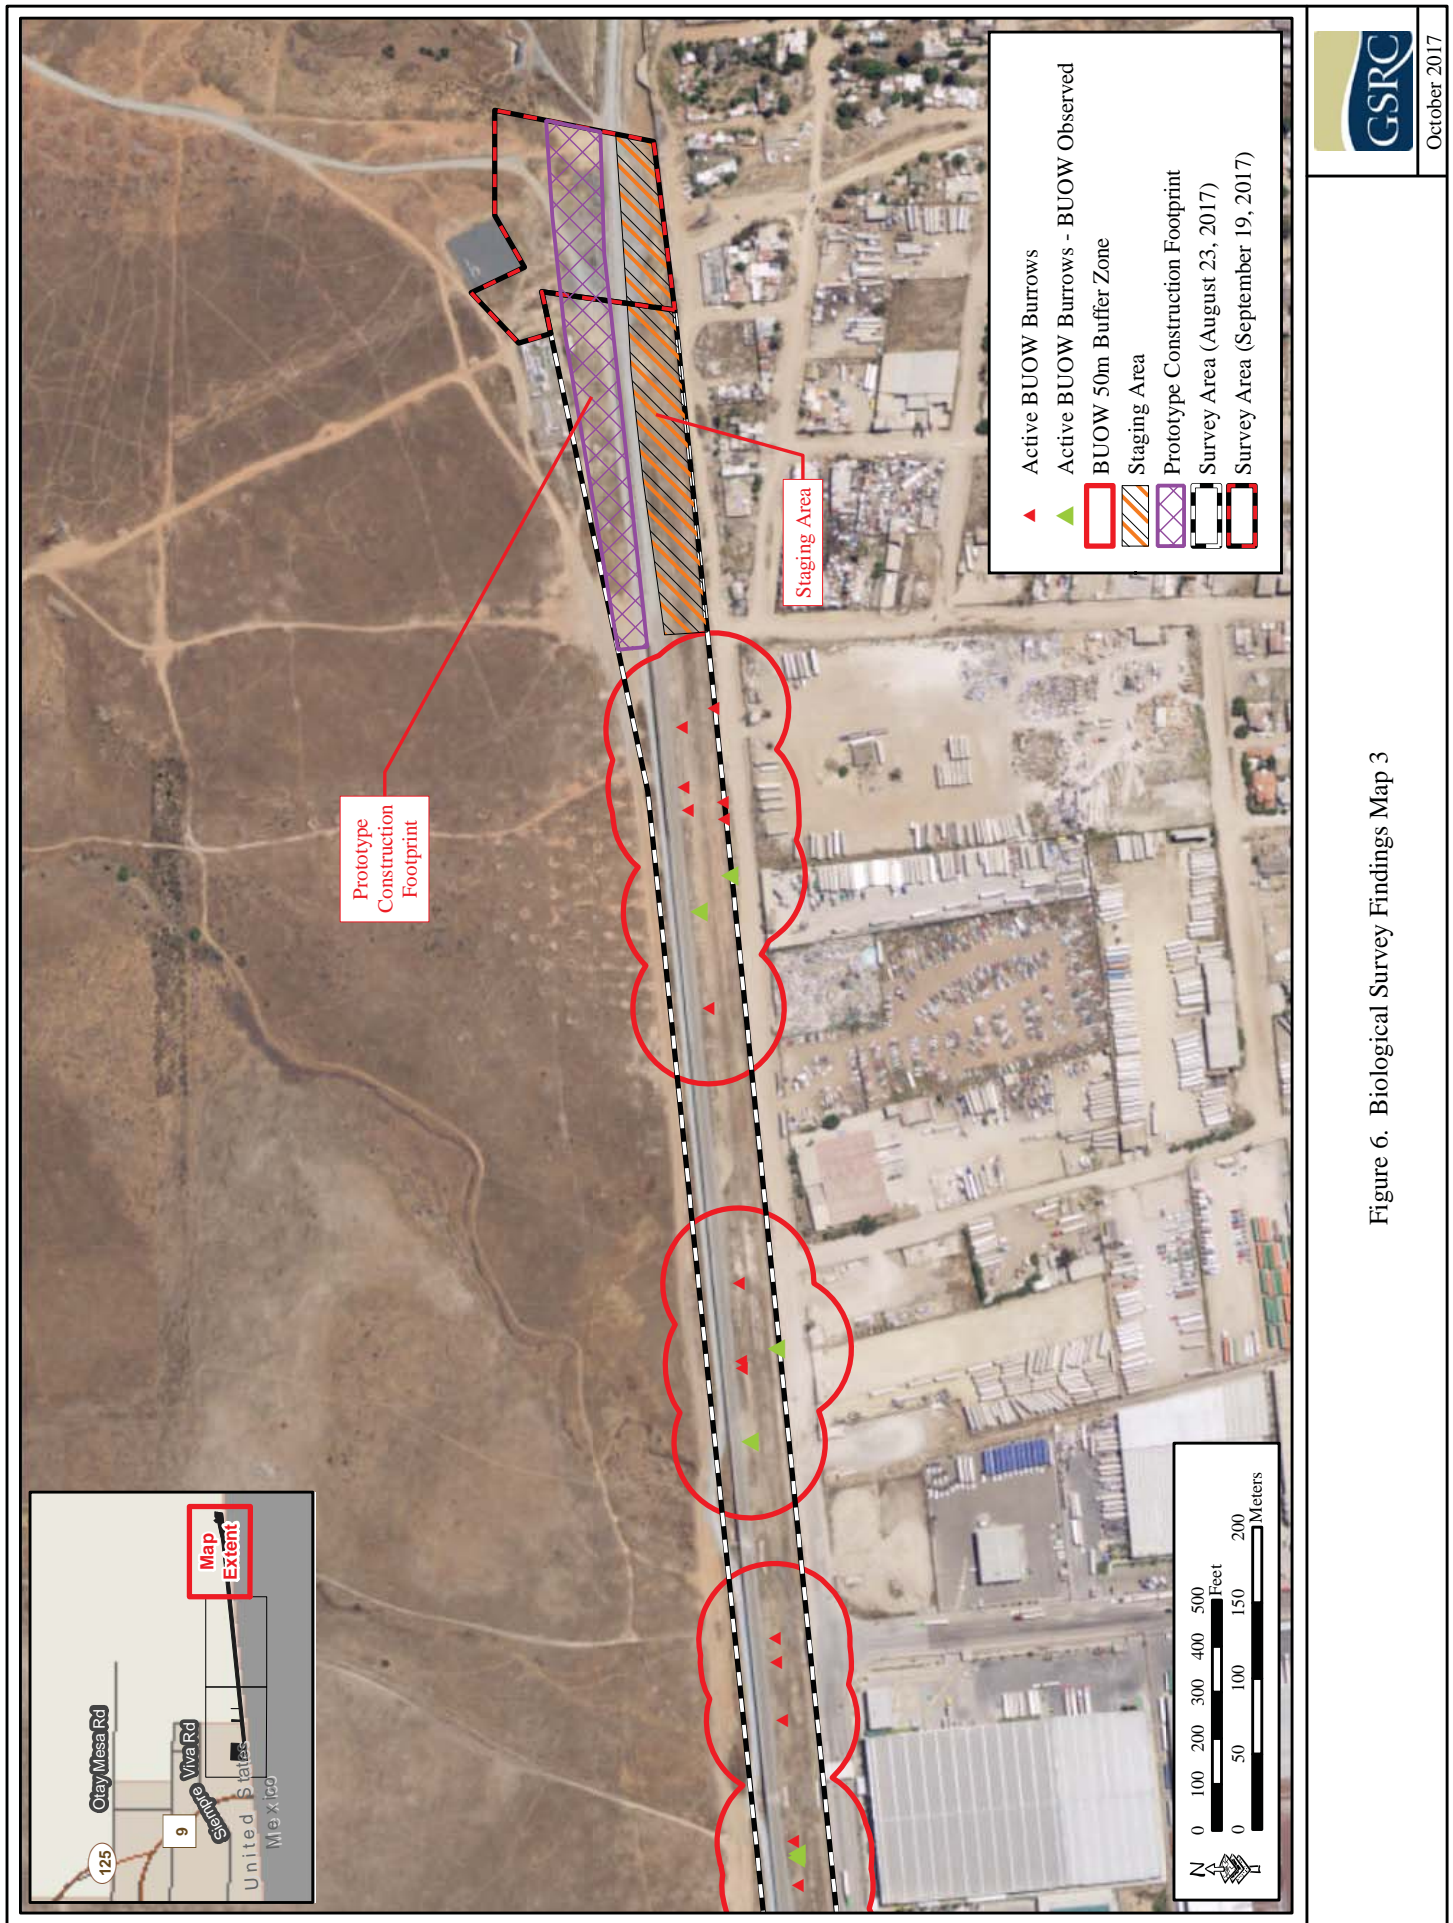
Figure 6. Biological Survey Findings Map 3

The SDC Border Wall Prototype construction site consists of mostly cleared ground (see Figure 3 and Figure 6). The vegetation present in this area is located adjacent to the existing border wall and is dominated by Russian thistle, Australian saltbush, cheeseweed mallow (*Malva parviflora*), foxtail grass (*Hordeum* sp.), black mustard (*Brassica nigra*), and crown daisy (Photograph 7).

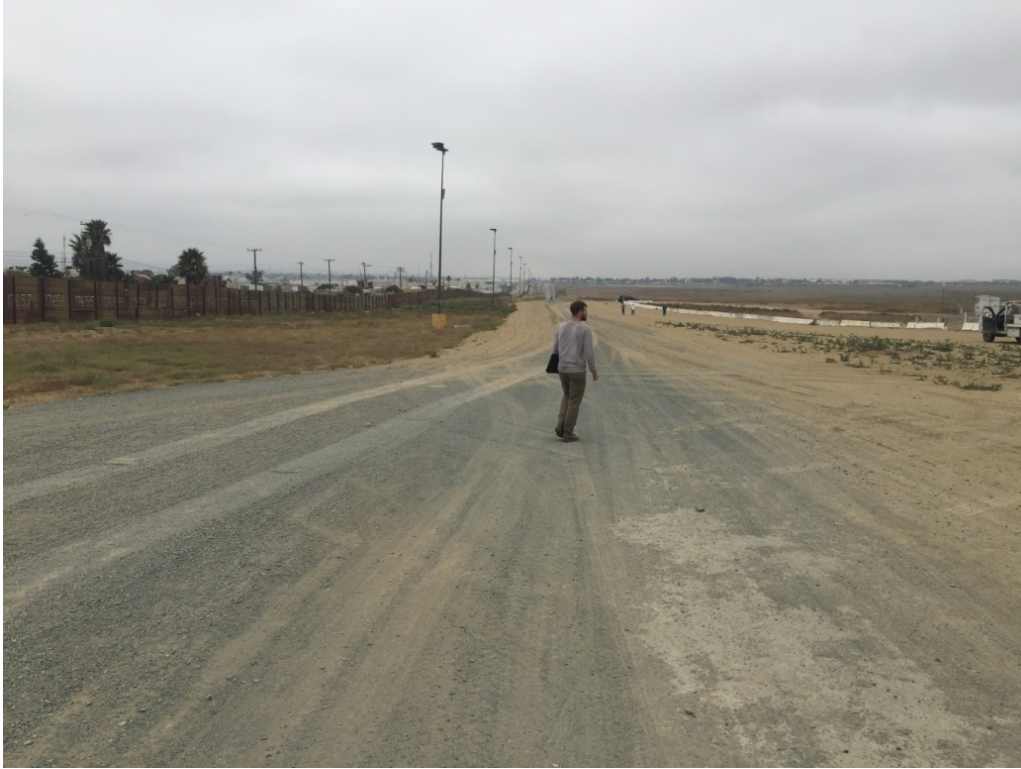
Photograph 7. The SDC Border Wall Prototype Project construction area, which is characterized as heavily disturbed non-native grassland and mixed herbaceous species habitat.
